Home Inspection Report

222 Happy St, Any Town U.S.A.

Inspection Date:
X/XX/XXXX

Prepared By:
All-Home Inspection Services
1445 John Street
Sycamore, IL 60178

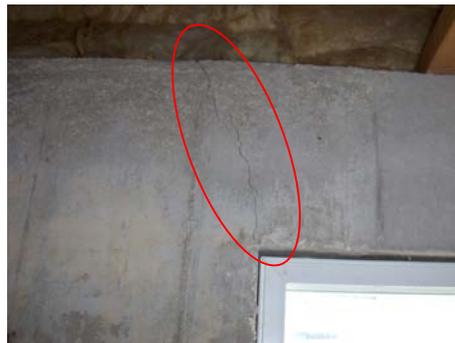
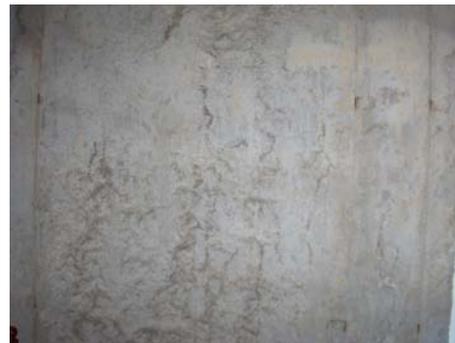
- **Monitor:** Minor vertical cracks were observed in the foundation in several locations. This type and pattern of cracking is usually the result of concrete shrinkage as it cures. Shrinkage cracks are very common and are not normally a concern.

- **Monitor:** Cold joints/cold pour were observed in the foundation walls. (Dark lines in the concrete or exposed stone) These are caused by the first concrete pour starting to take a set before the second load was poured. This is not a structural concern. In rare cases some seepage could occur along the joint or where stones are exposed.

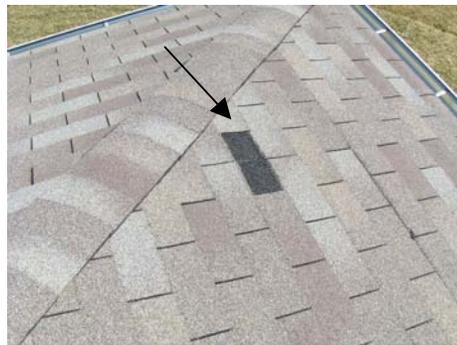
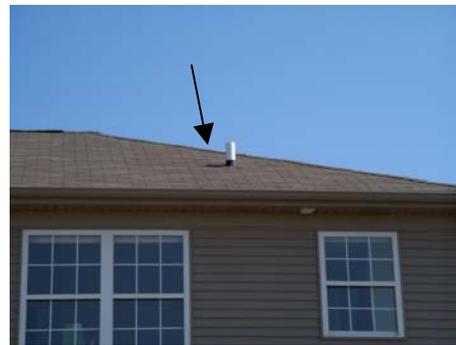
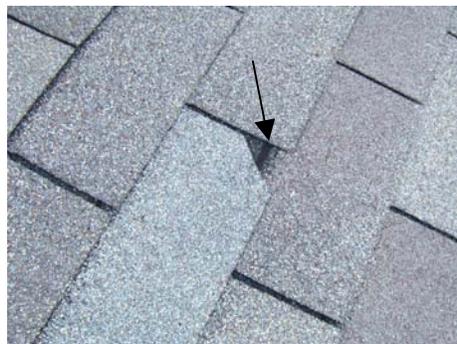
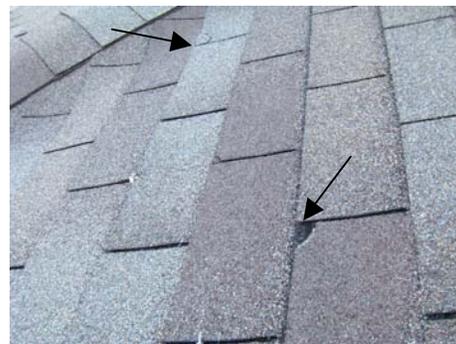
- **Repair:** Minor repairs to the roofing are needed. Damaged or missing roofing material should be repaired. All roof penetrations should be examined and sealed as necessary.

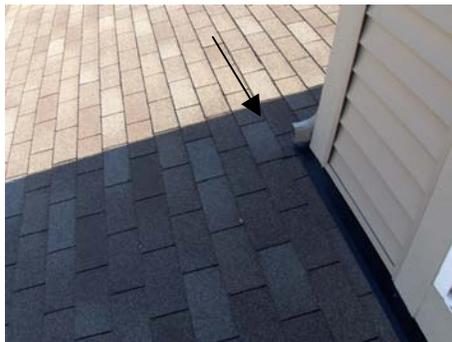
- **Improve:** Downspout(s) that discharge onto the roof should be extended to discharge directly into the gutters below. This condition, if left unattended, can result in premature deterioration of the roofing under the end of the downspout.

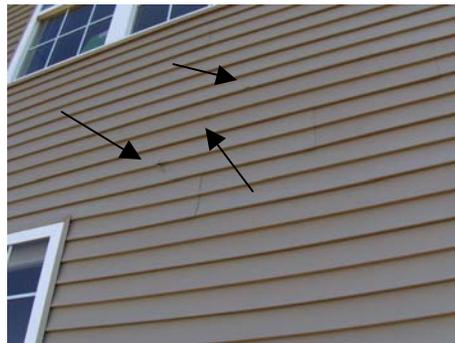
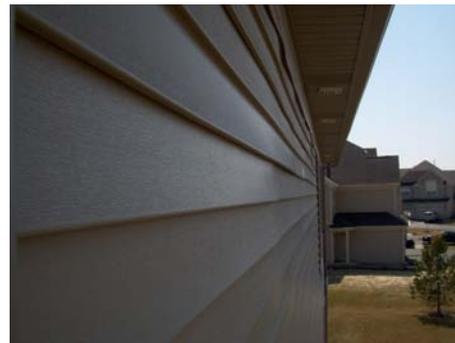
- **Repair:** Minor siding damage was observed at the west side of the home. Sealing these areas or replacement is recommended.

- **Monitor:** The siding is buckled at the upper west side of the home. Adjustment may be needed.

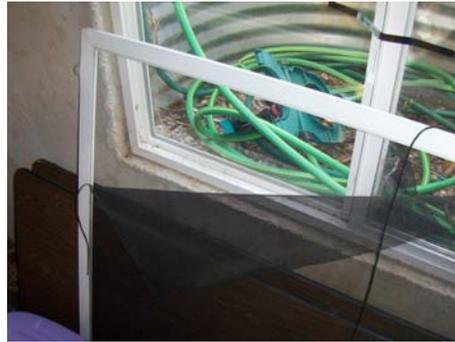
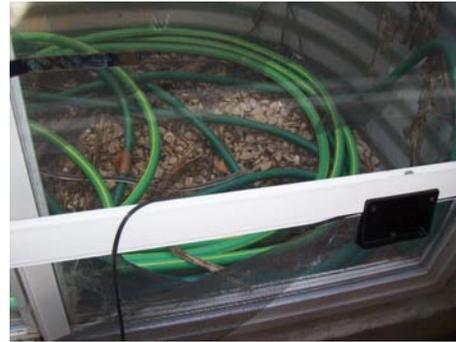
- **Repair:** The screen for the sliding glass door is damaged. (Currently in basement)

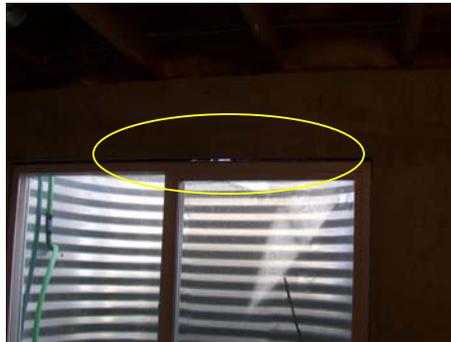
- **Repair:** A basement window screen is damaged.
- **Repair:** A basement window is in need of re-sealing at the top of the window.

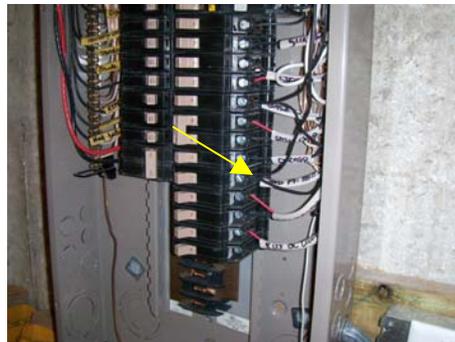
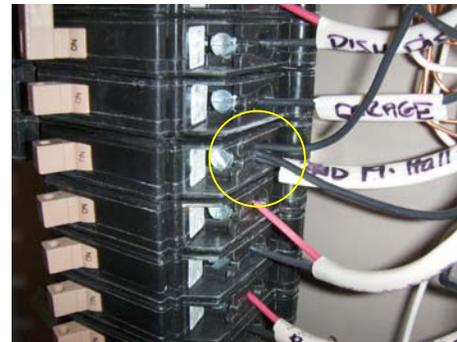
- **Repair:** Circuits within the main distribution panel that are doubled up (referred to as "double taps") should be separated. Each circuit should be served by a separate fuse or breaker.

- **Improve:** The main distribution panel has missing mounting screws. Missing screws could cause panel to become loose and/or interfere with proper circuit breaker operation.

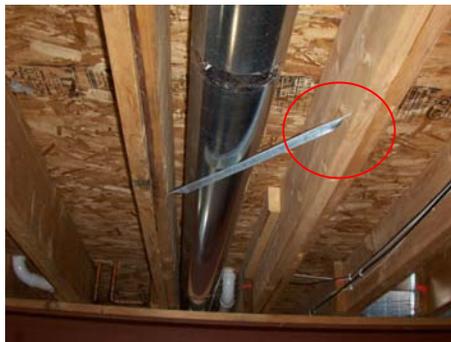
- **Repair:** A support brace for a heating duct is missing/loose and needs repair.

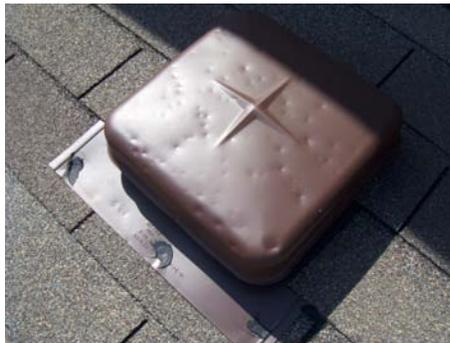
- **Monitor:** Insulation improvements above the **garage** may be cost effective, depending on the anticipated term of ownership. It is generally recommended that 10-12 inches of R-30 or better insulation with an air vapor barrier be installed. This should help to reduce heating costs and help keep the home cooler during warm weather.
- **Monitor:** The roof vents on the east slope appear to have hail damage.

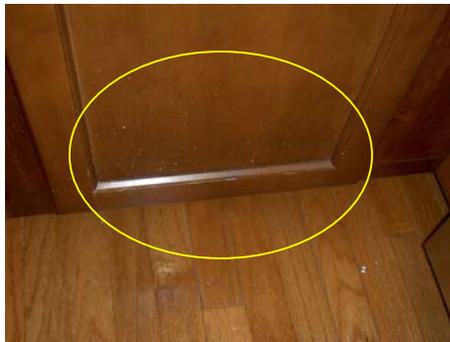
- **Monitor:** Possible paint spatter was observed on a cabinet door.
